Here is a photo of the Canon Pixma MP830 with the scanner section raised to show the installation of the Continuous Ink System (CIS).

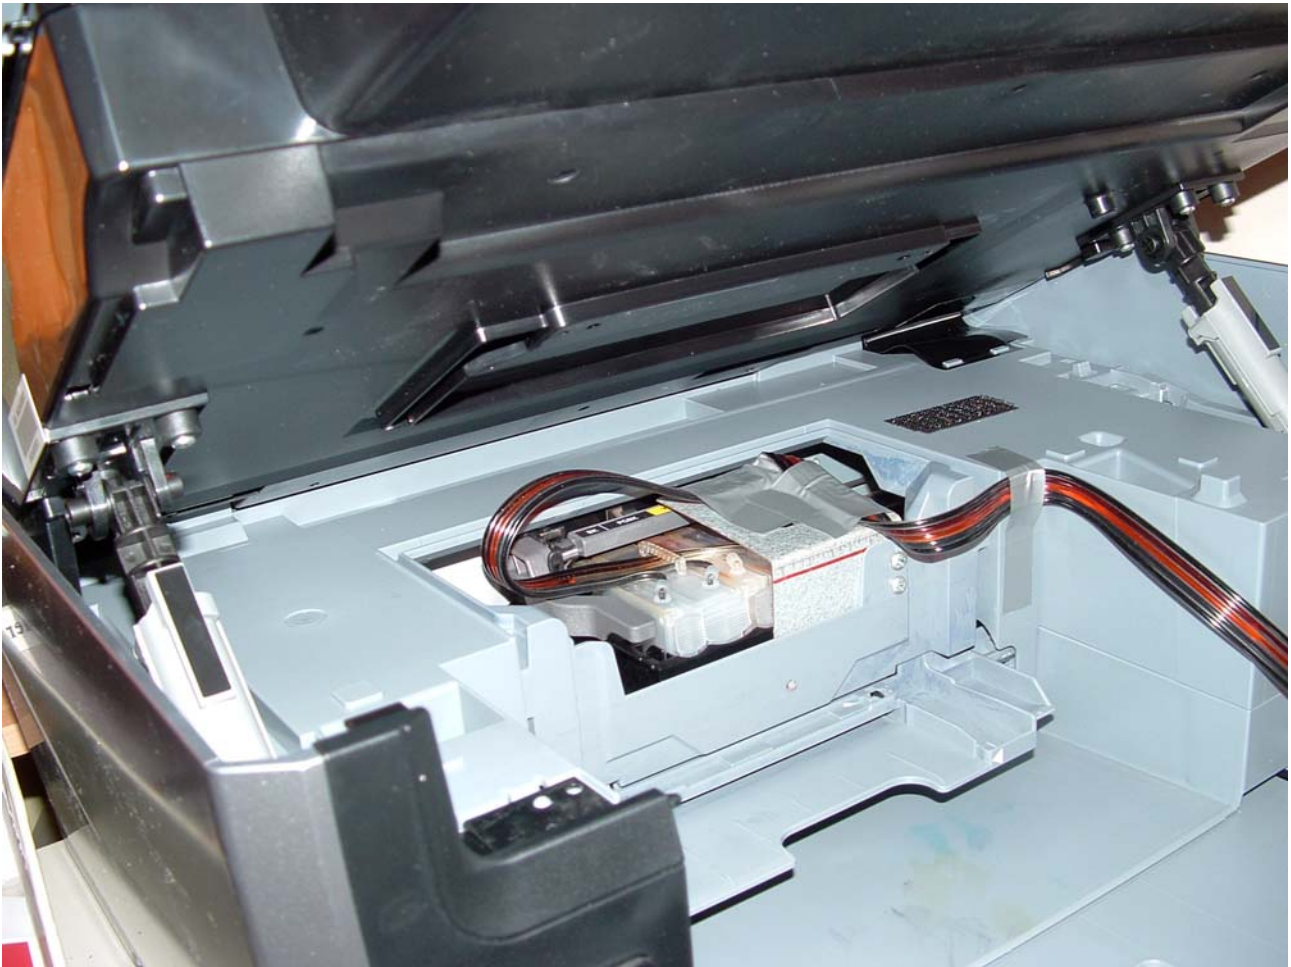
Canon have implemented two elements into the design to make the installation of a CIS difficult.

The first problem is caused by a gutter around the cartridge access area in the lower part of the MP830 (printer section), with a mating ridge in the upper part of the MP830 (scanner section).

If you install the ink tube ribbon using the printer installation method, this gutter will pinch the ribbon and block the ink flow when you lower the scanner section.

The second problem is caused by a “blocker” panel which is attached to the underside of the scanner section. This hinged panel interfaces with an assembly in the lower printer section of the MP830, to effectively block access to the cartridge area. Fortunately this panel can be taken off easily by removing the two screws that secure it. It serves no other purpose.

By removing this “blocker” panel, the front of the cartridge area can now be accessed, which provides a route for our ink tube ribbon.
